Replacing the Drum Unit

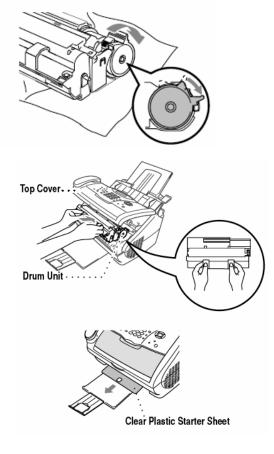
- 7. Holding the new drum unit by its handles, install it. Close the top cover.
- 8. The FAX/MFC will eject the clear plastic starter sheet automatically.
